INVESTIGATION REPORT
199904538

Boeing 747-438, VH-OJH Bangkok, Thailand

23 September 1999

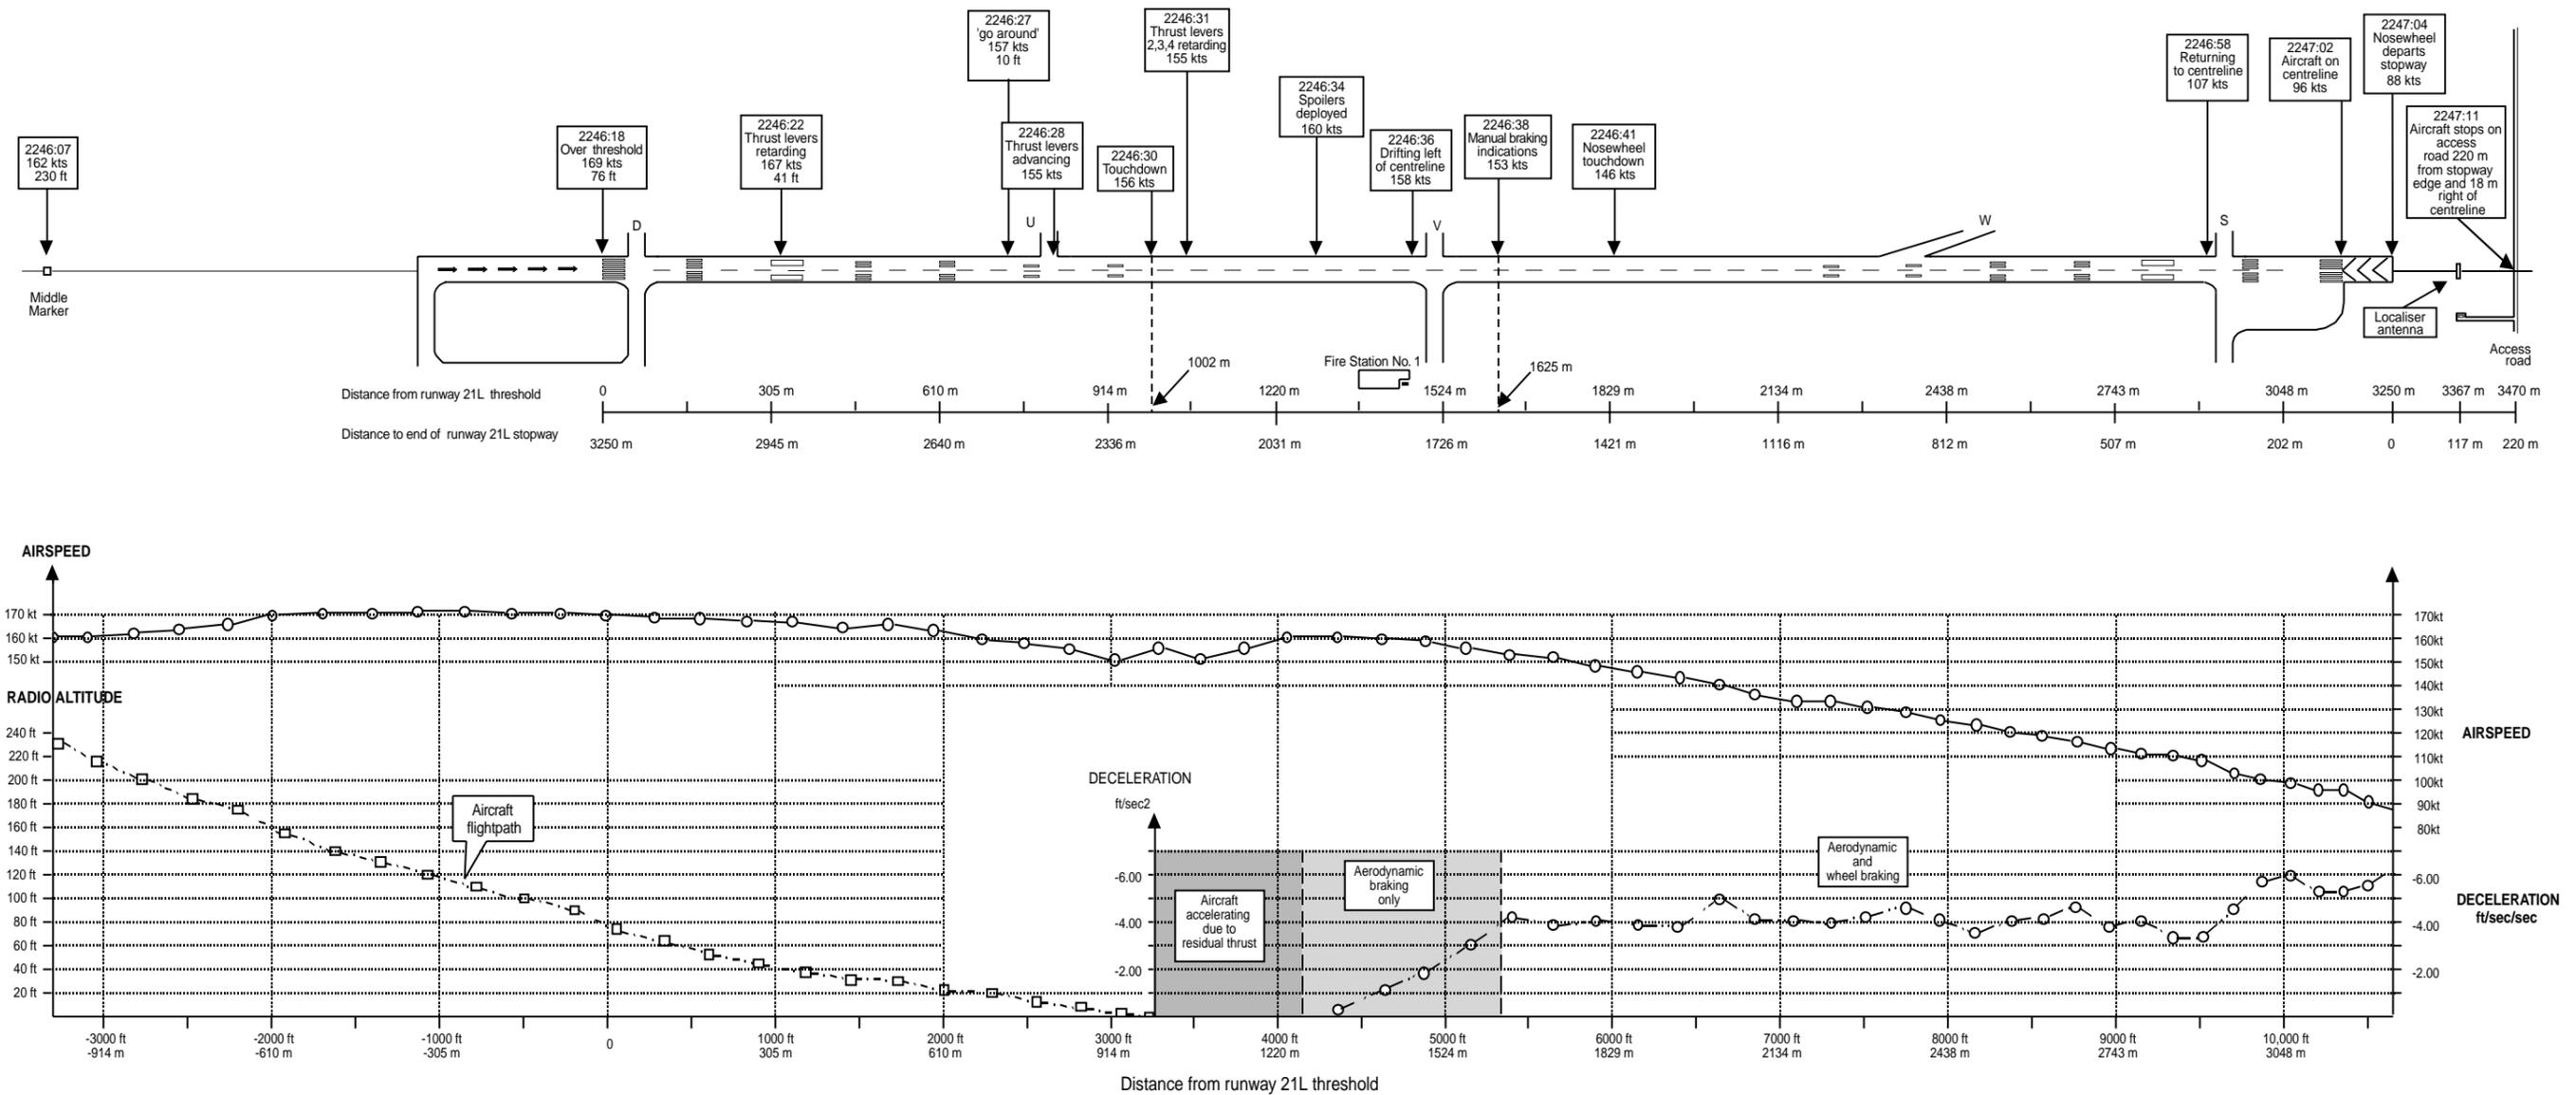
The Qantas One crew noted no effect from the weather until visibility reduced when the aircraft entered very heavy rain as it descended through 200 ft on late final approach. The aircraft then started to deviate above the 3.15 degree glideslope, passing over the runway threshold at 169 kts at a height of 76 ft. Those parameters were within company limits. (The target speed for the final approach was 154 kts, and the ideal threshold crossing height was 44 ft.)

Figure 1:
Flight profile during approach and landing (adapted from Qantas Flight Safety Department diagram)

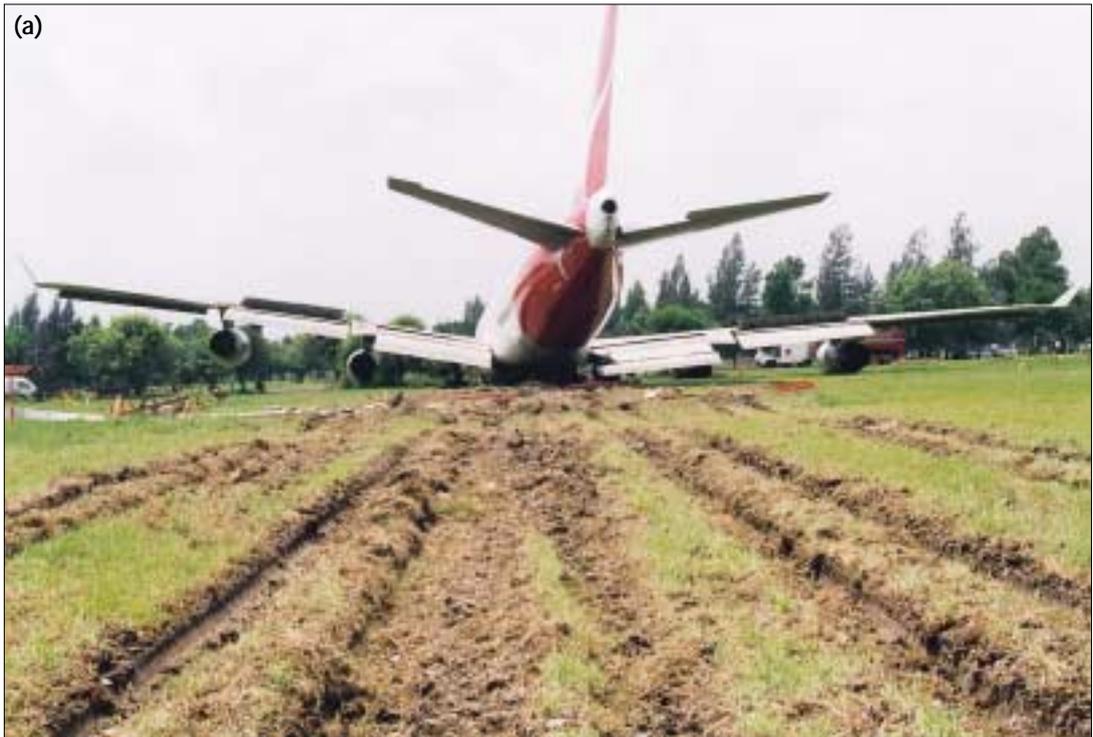
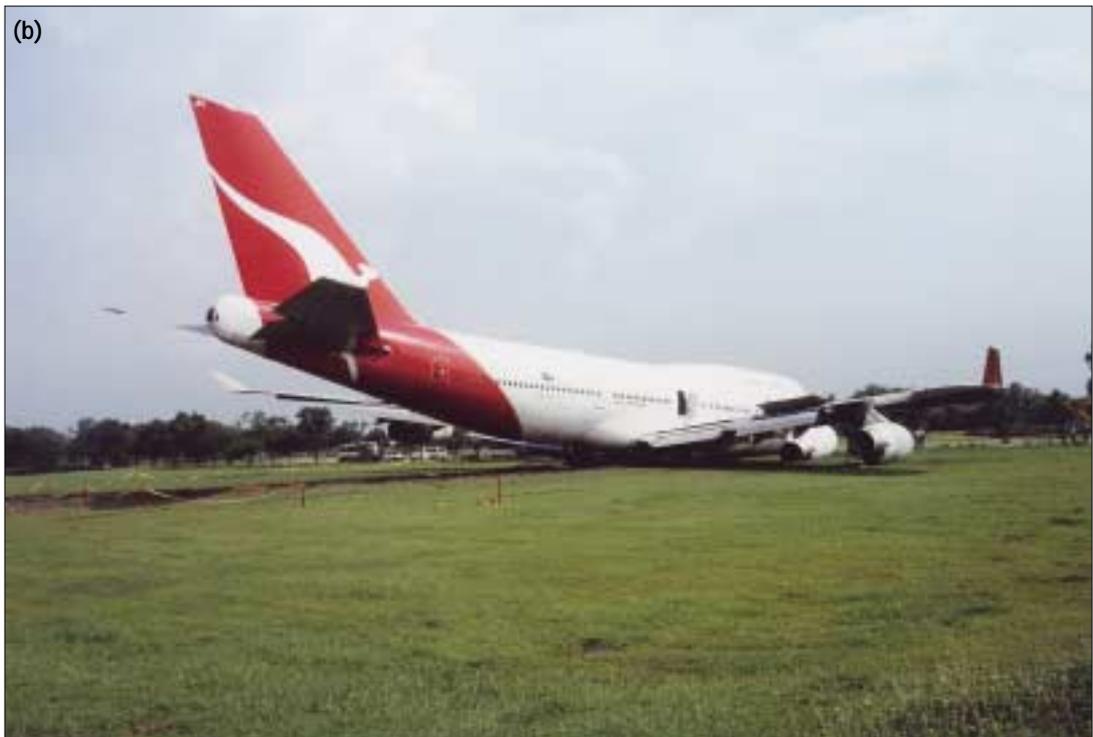
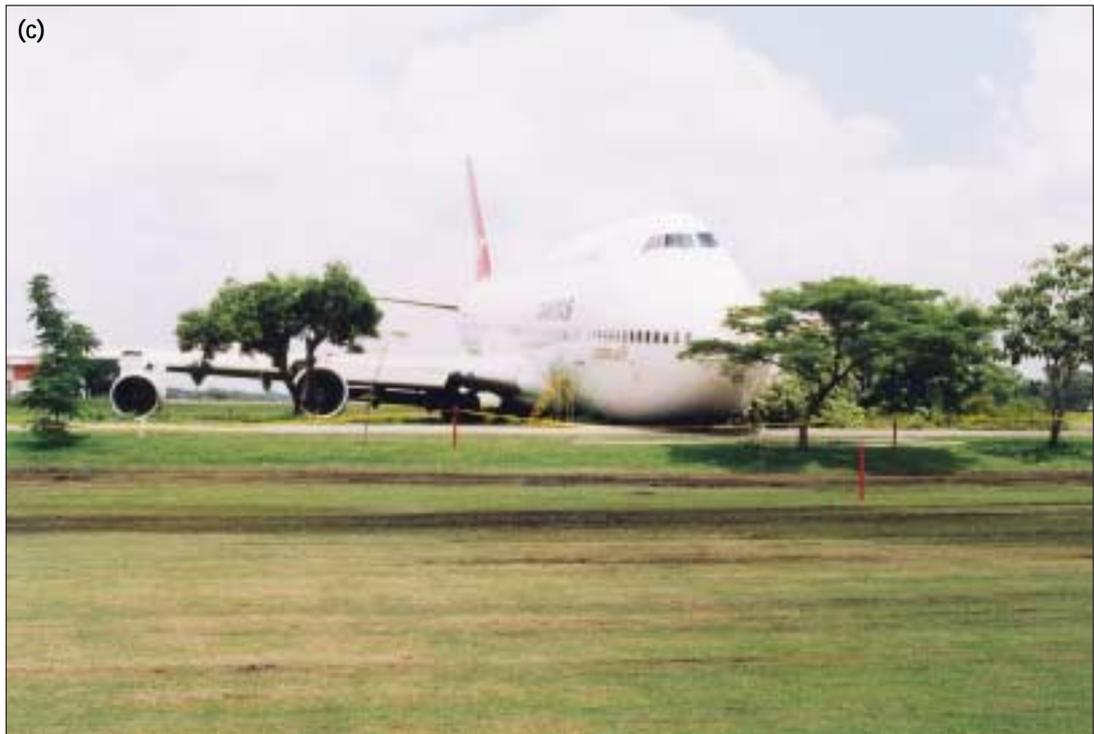
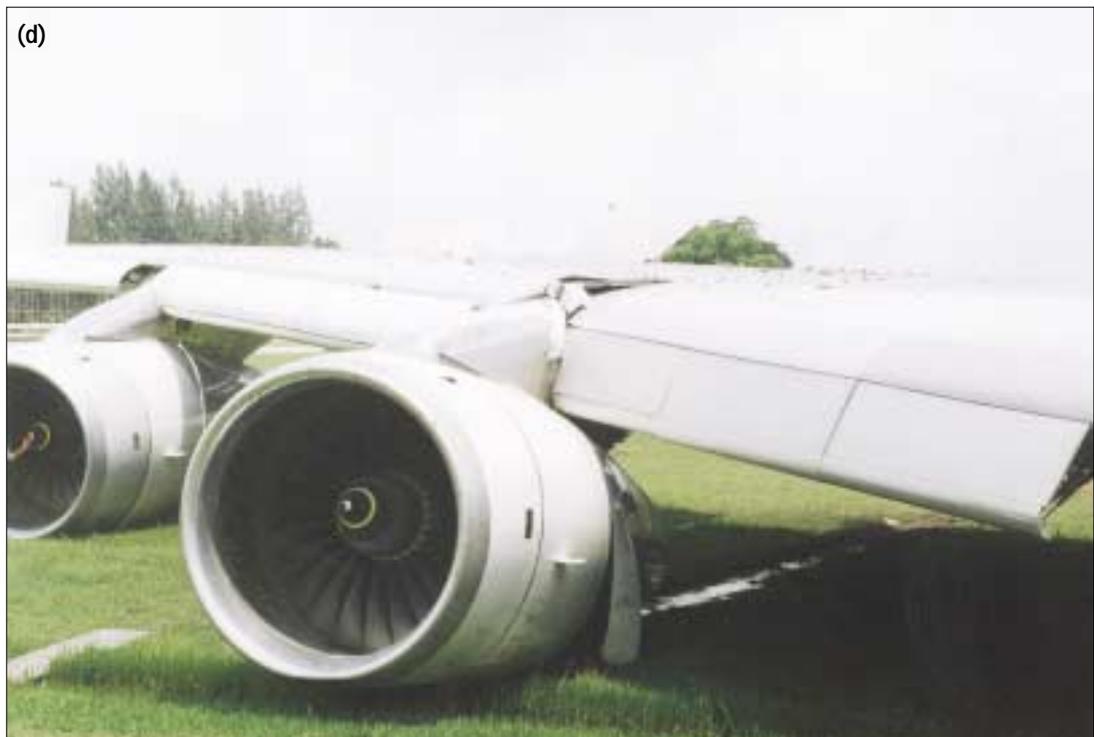
The main areas of damage to the aircraft were the lower forward fuselage, the nose and right wing landing gear and landing gear bays, and the engines. Numerous cabin fittings dislodged during the accident sequence. As a result of the nose landing gear collapsing rearwards and upwards into the lower fuselage, the cabin passenger address system and the interphone system for communications between the flight deck and the cabin became inoperable.

Figure 2:
Accident aircraft in its final resting position: (a) rear view; (b) side view.

Figure 2 (continued):
Accident aircraft in its final resting position: (c) front view; (d) close view of number 3 engine.

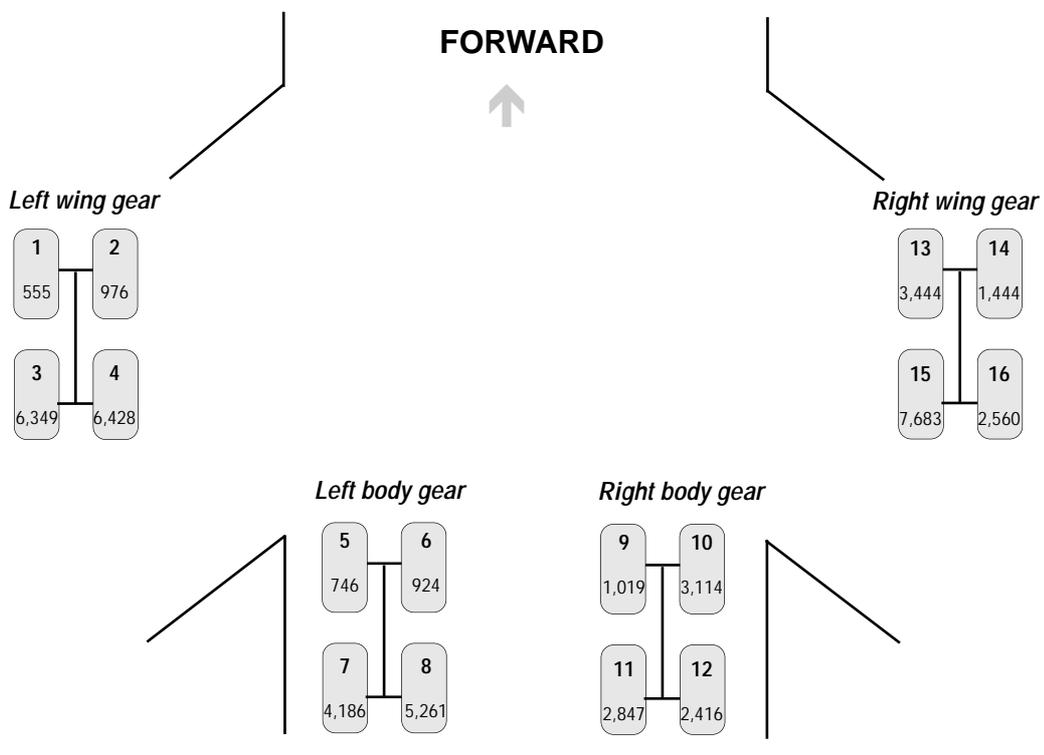
Figure 3:
B747-400 mainwheel configuration and average recorded brake torques (N.m) during the landing roll

During the previous (normal) landing of the aircraft on a dry runway, the average brake torque values recorded were approximately 20,000 N.m. Boeing advised that this value was typical for dry runway conditions.

In more usual wet conditions, Boeing has seen that the fore-aft wheels in a tandem pair generate similar brake torque, but differ from the axel-mates because each tandem set on the truck is sampling a slightly different path down the runway. This is more consistent with what was seen in the recorded brake torque data for the wheels on the right side of the airplane.

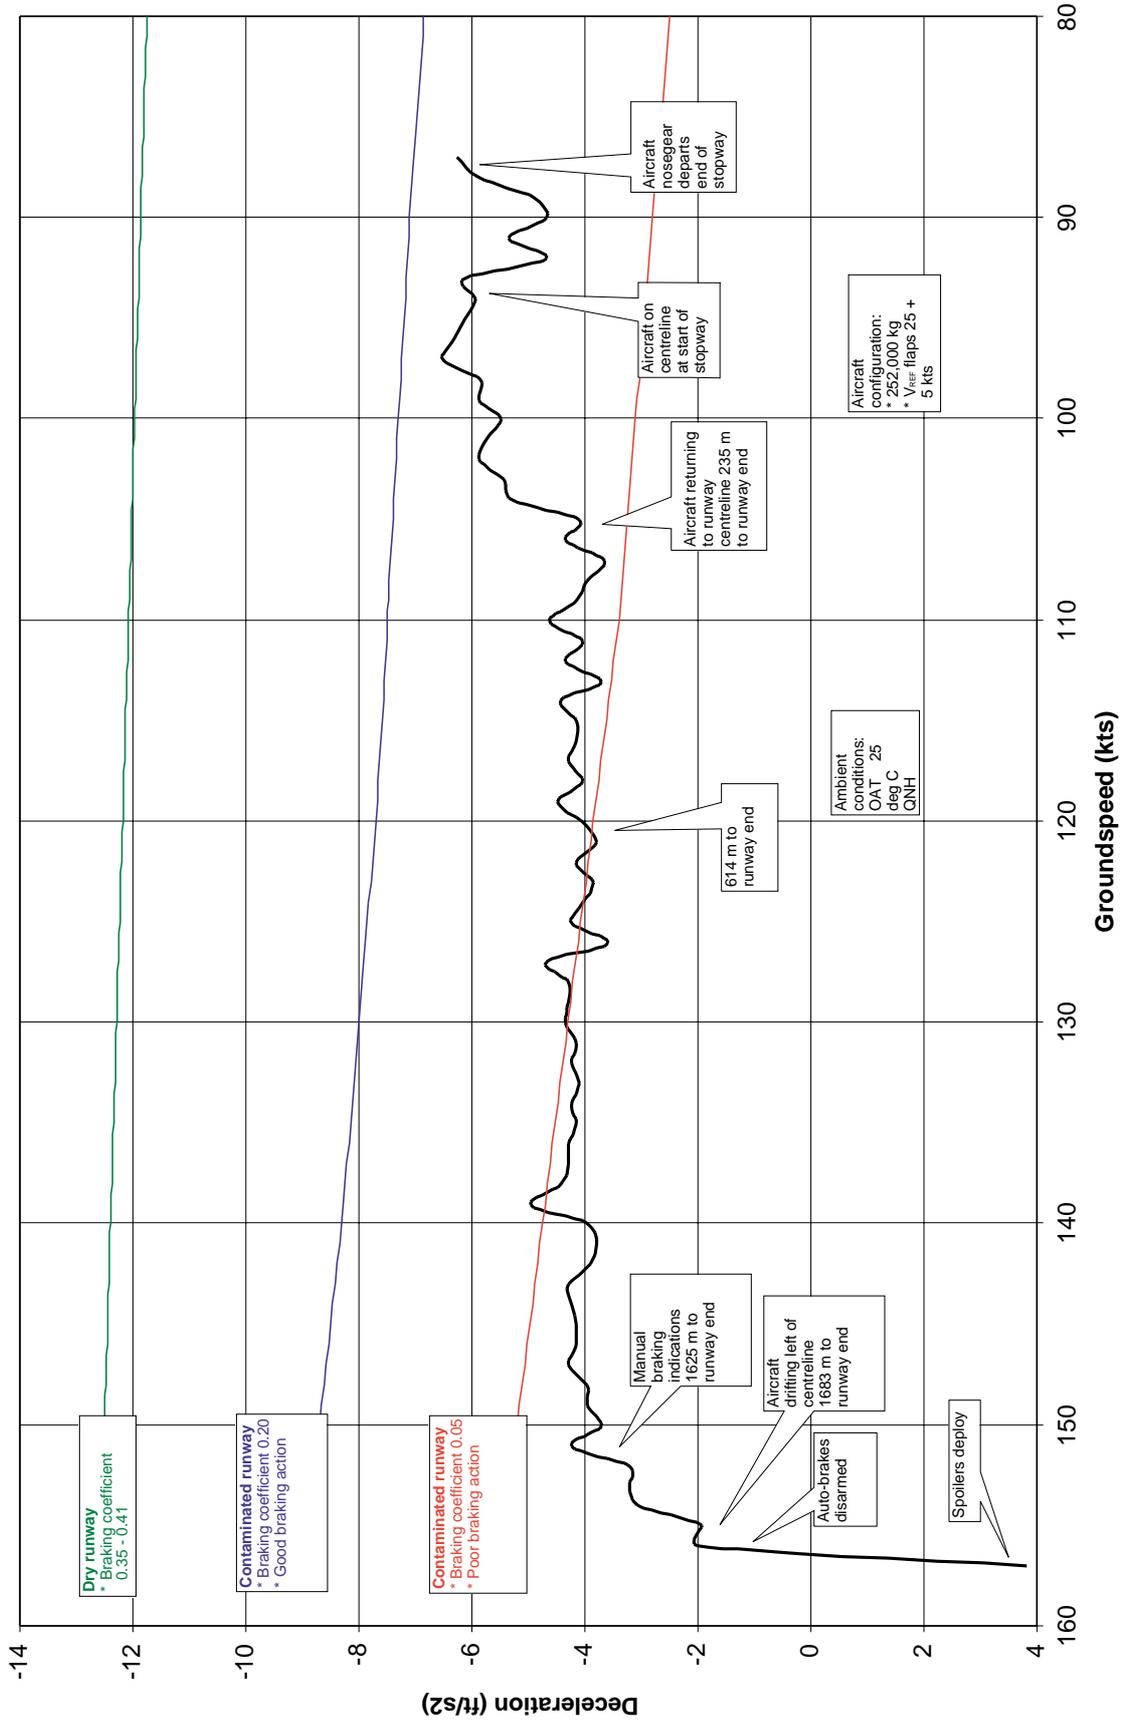
The investigation established that, during the landing roll, the aircraft tyres aquaplaned on the water-affected runway. This limited the effectiveness of the wheelbrakes to about one third of that for a dry runway. In such conditions and without reverse thrust, there was no prospect of the crew stopping the aircraft in the runway distance remaining after touchdown. The aircraft overran the 100 m stopway (at the end of the runway) at a speed of 88 kts, before stopping 220 m later with the nose resting on an airport perimeter road.

Figure 4:
Comparison of rollout deceleration with dry and contaminated runways (adapted from Qantas Flight Safety Department diagram)

Fig. 4 shows the rate of deceleration achieved by the aircraft compared with data supplied by Boeing for braking performance on dry, wet, and flooded runways. The initial rate of deceleration stabilised at about 4 ft/s² during the period of manual braking and approximated an airplane braking coefficient of .05. This equated to 'poor' braking action. Between approximately 350 m and 200 m before the stopway end, the deceleration rate increased to about 6 ft/s², approximating 'medium' to 'good' braking action. The deceleration rate started to increase as the aircraft speed was reducing through 108 kts.

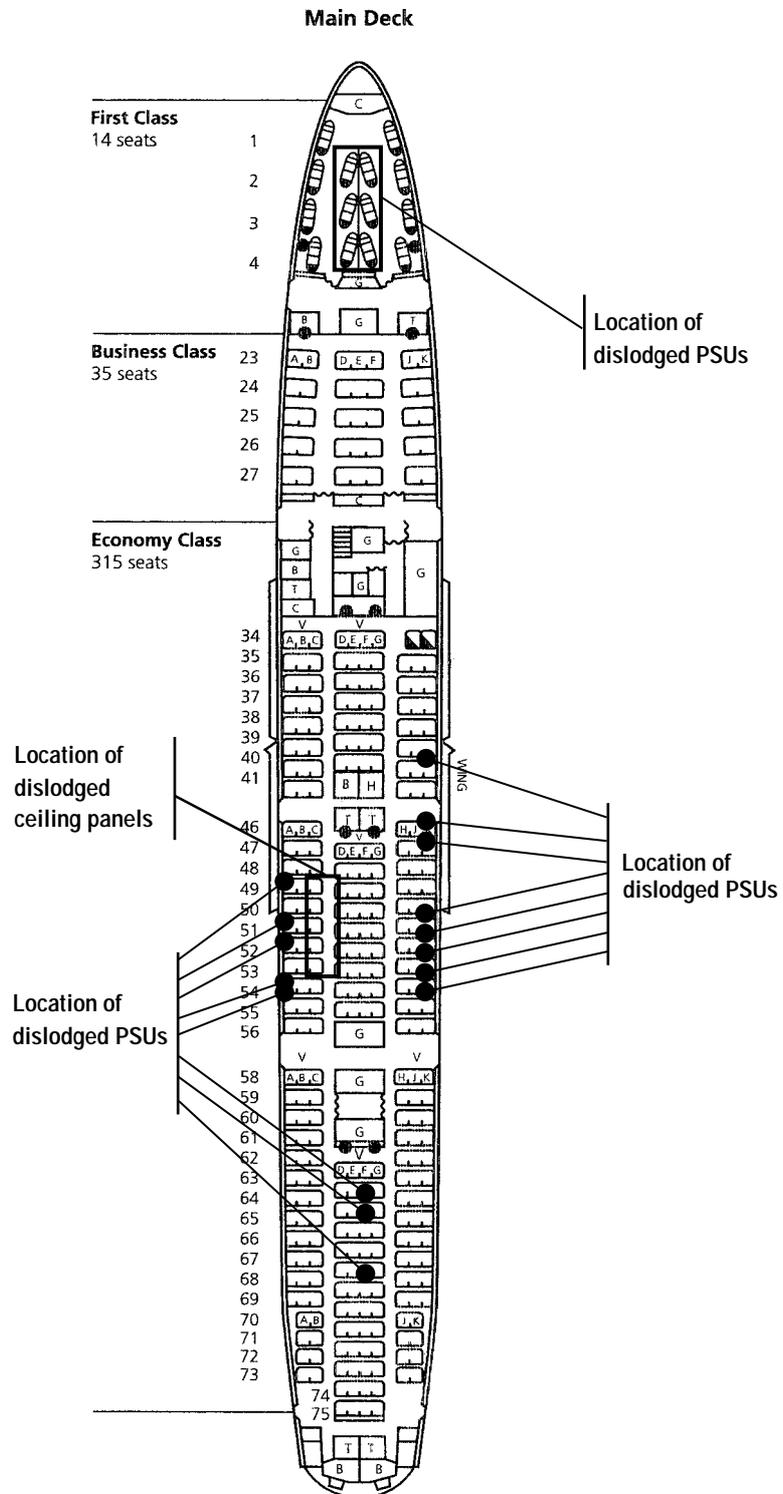
Figure 7:
Layout of aircraft cabin showing cabin damage

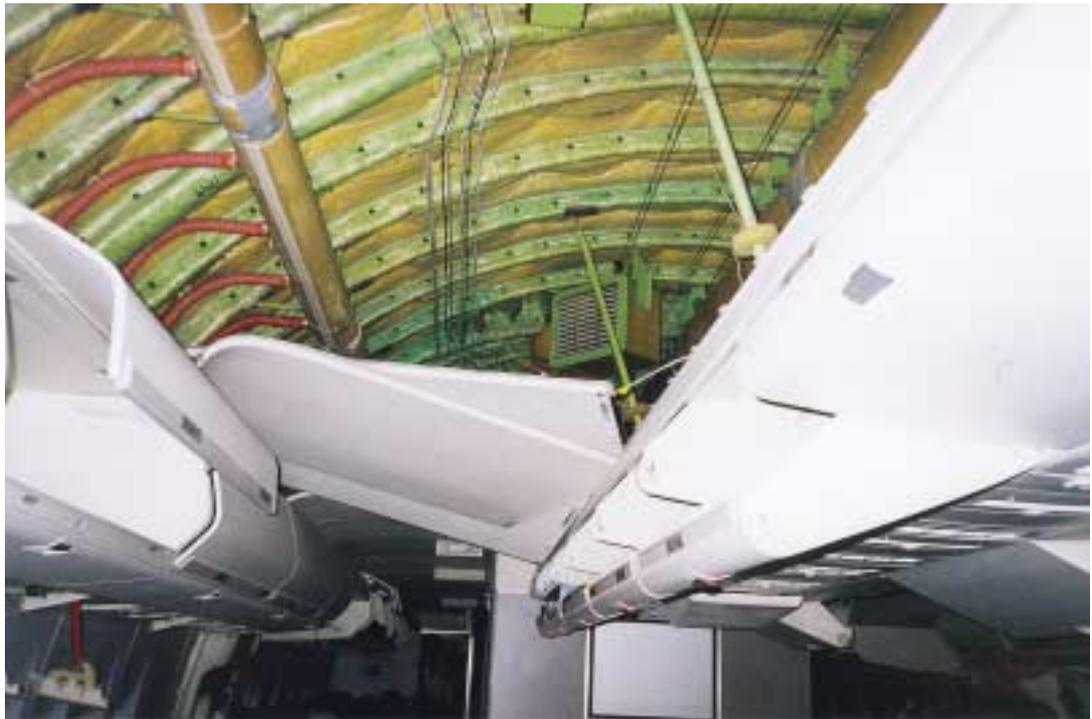
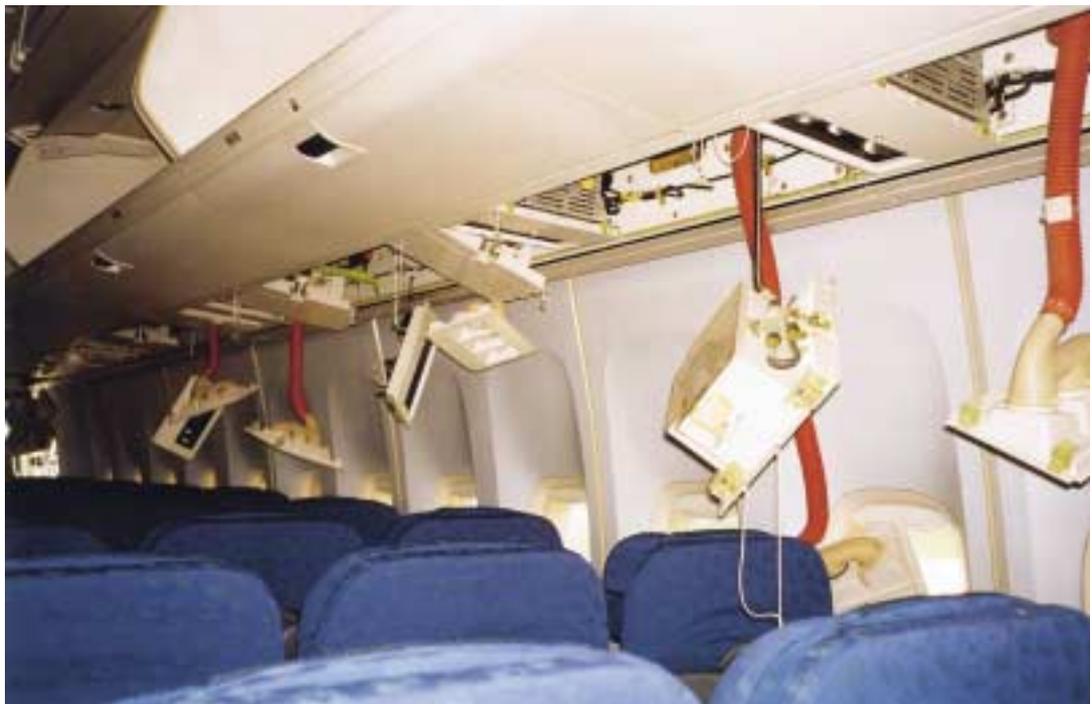
Figure 8:
Examples of dislodged cabin fittings: (a) ceiling panels and (b) passenger service units (PSUs)

Table 8 also shows the certification standards for cabin fittings, as stipulated in FAR 25.561. The aircraft was certified according to this standard. As shown in table 8, the deceleration values experienced during the impact sequence were below those stipulated by the FAR requirements.
