INVESTIGATION REPORT
199904538

Boeing 747-438, VH-OJH Bangkok, Thailand

23 September 1999

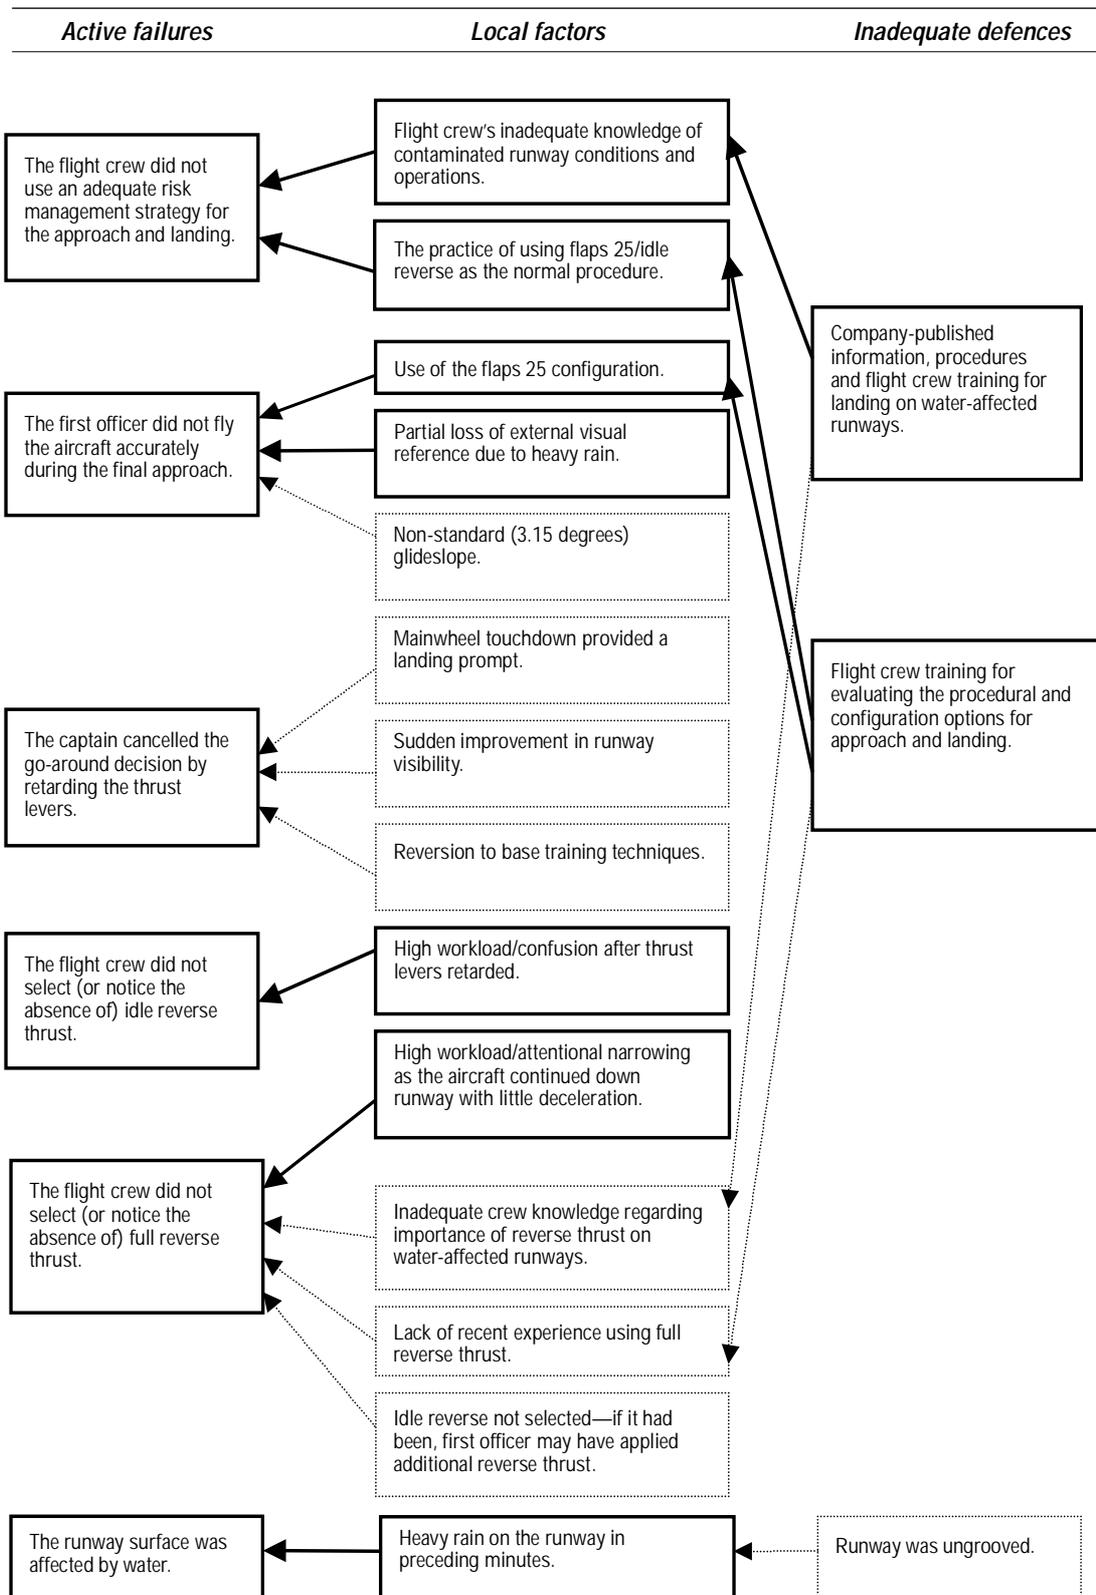
Figure 5:
Summary of the active failures, local factors and inadequate defences associated with the accident flight (significant factors are in fully enclosed boxes)

As shown in fig. 5, the investigation concluded that deficiencies in two primary defences had a significant influence on the development of the accident. These were:

Weaknesses in a number of other defences such as the company's CRM program, the training and role definition of second officers, and procedures concerning recency, possibly contributed to the development of the accident. However, as discussed in section 1.8, there was insufficient evidence to conclude that these issues had any role in the development of the accident.

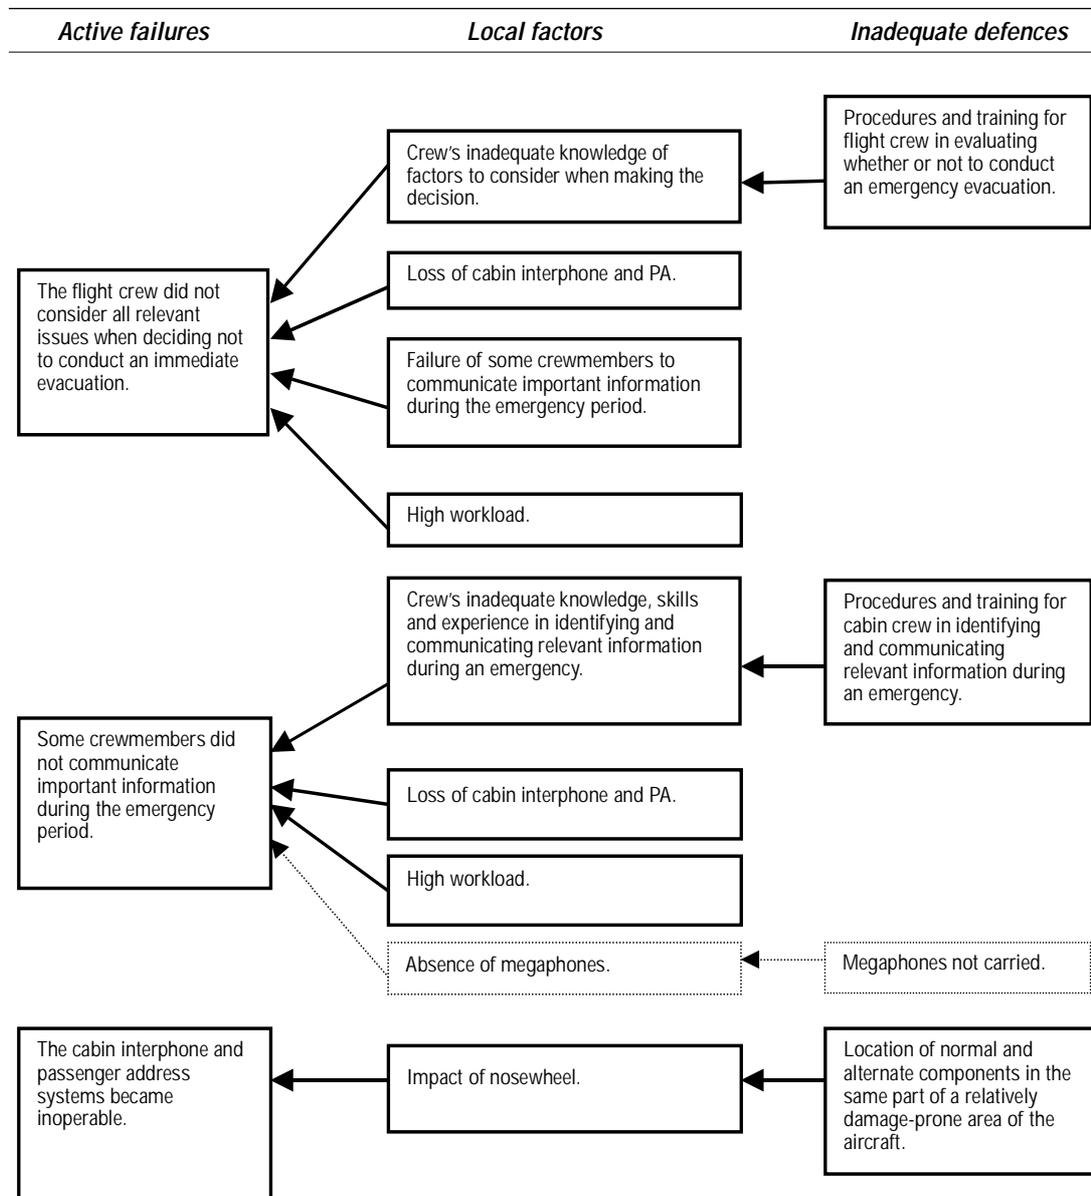
Figure 10:
Summary of active failures, local factors and inadequate defences associated with post-accident events and cabin safety issues (significant factors are in fully closed boxes)

Contributing factors and the potential effects of these active failures are discussed in sections 2.4, 2.5 and 2.6. They are also summarised in fig. 10.

- Procedures and training for flight crew in evaluating whether or not to conduct an emergency evacuation.
- Procedures and training for cabin crew in identifying and communicating relevant information during an emergency.

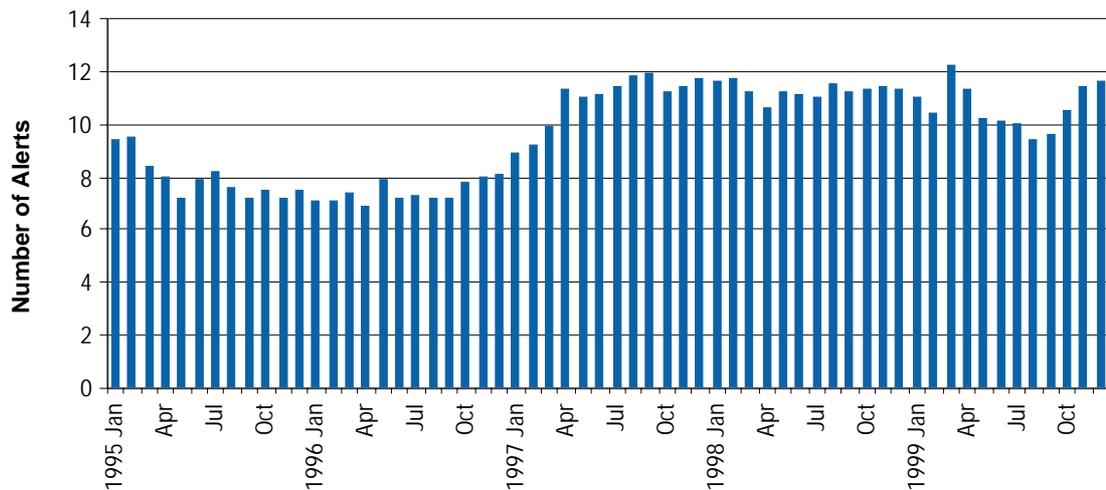
Figure 11:
Twelve-month moving average of the rate of parameter 161 alerts

Fig. 11 shows the 12-month moving average rate of parameter 161 alerts for the period from January 1995 to September 1999. That is, the data point for each month represents the rate of parameter 161 alerts for the preceding 12 months (including that month). This figure indicates that an increase occurred near the end of 1996.

The absolute rates of both QAR events listed in table 8 were low. However, statistical analysis indicated that there was a significant difference in the number of alerts for parameter 161 before and after the flaps 25/idle reverse procedures were introduced (December 1996).

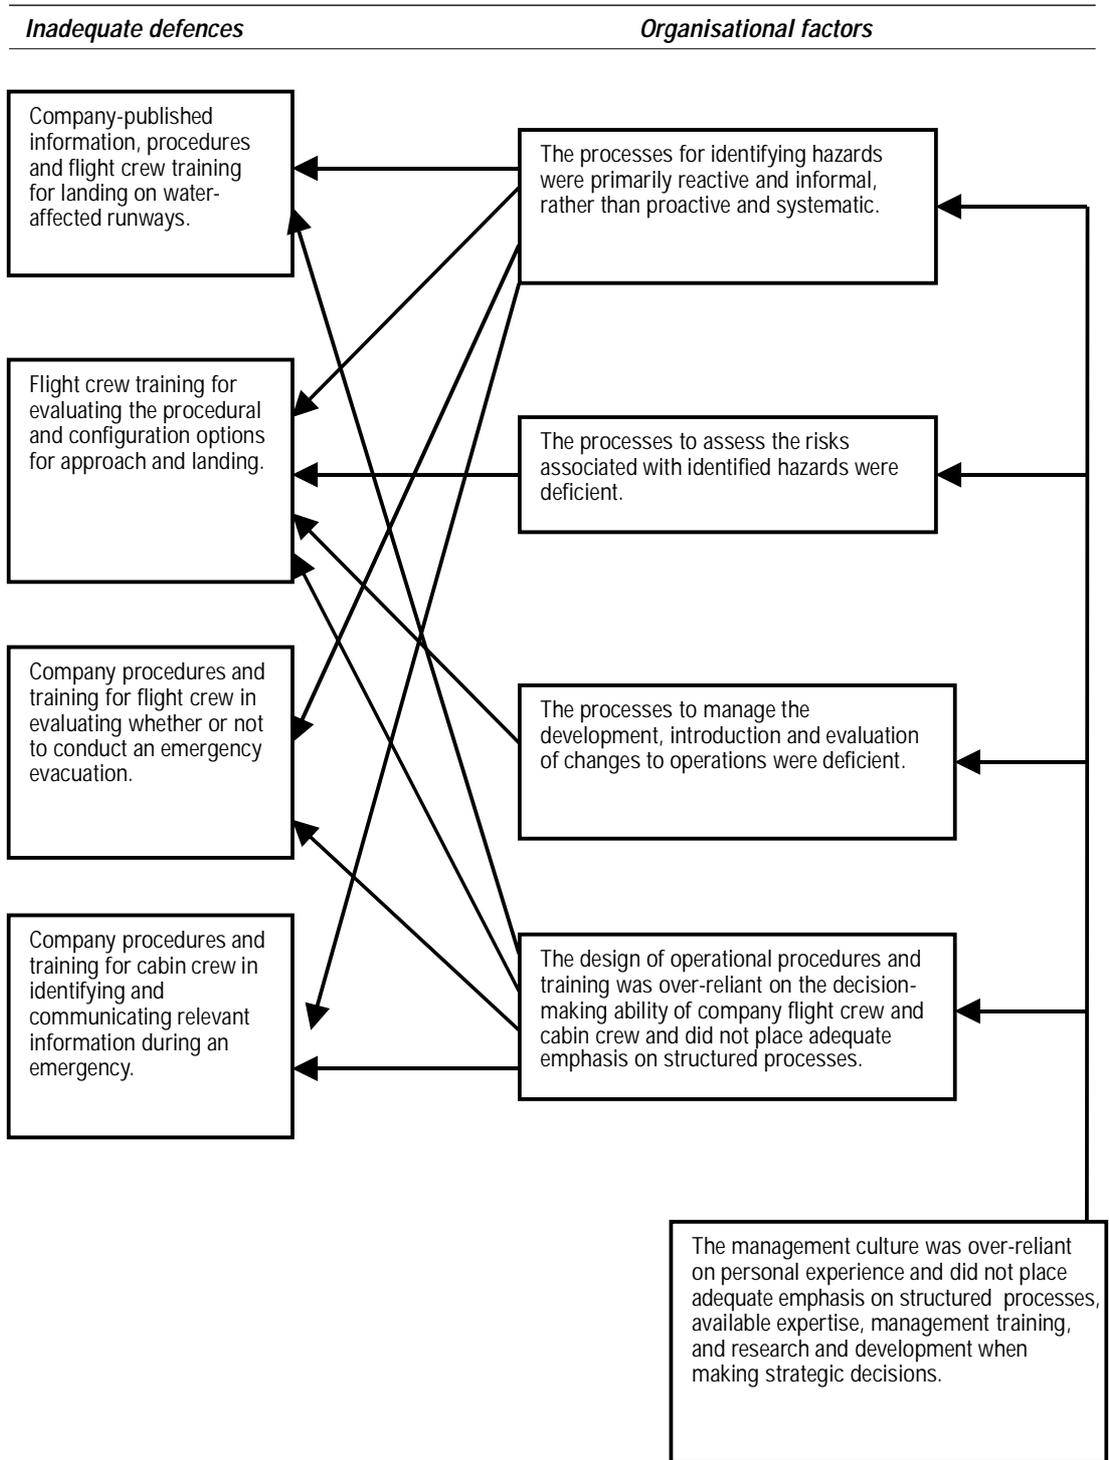
Figure 12:
Inadequate defences and organisational factors in Qantas flight operations

The relationship between these factors and the inadequate defences identified in parts 1 and 2 is outlined in fig. 12.

CASA's limited product surveillance activities had not detected the inadequate defences and organisational factors identified in parts 1, 2 and 3 of this report (see fig. 12).

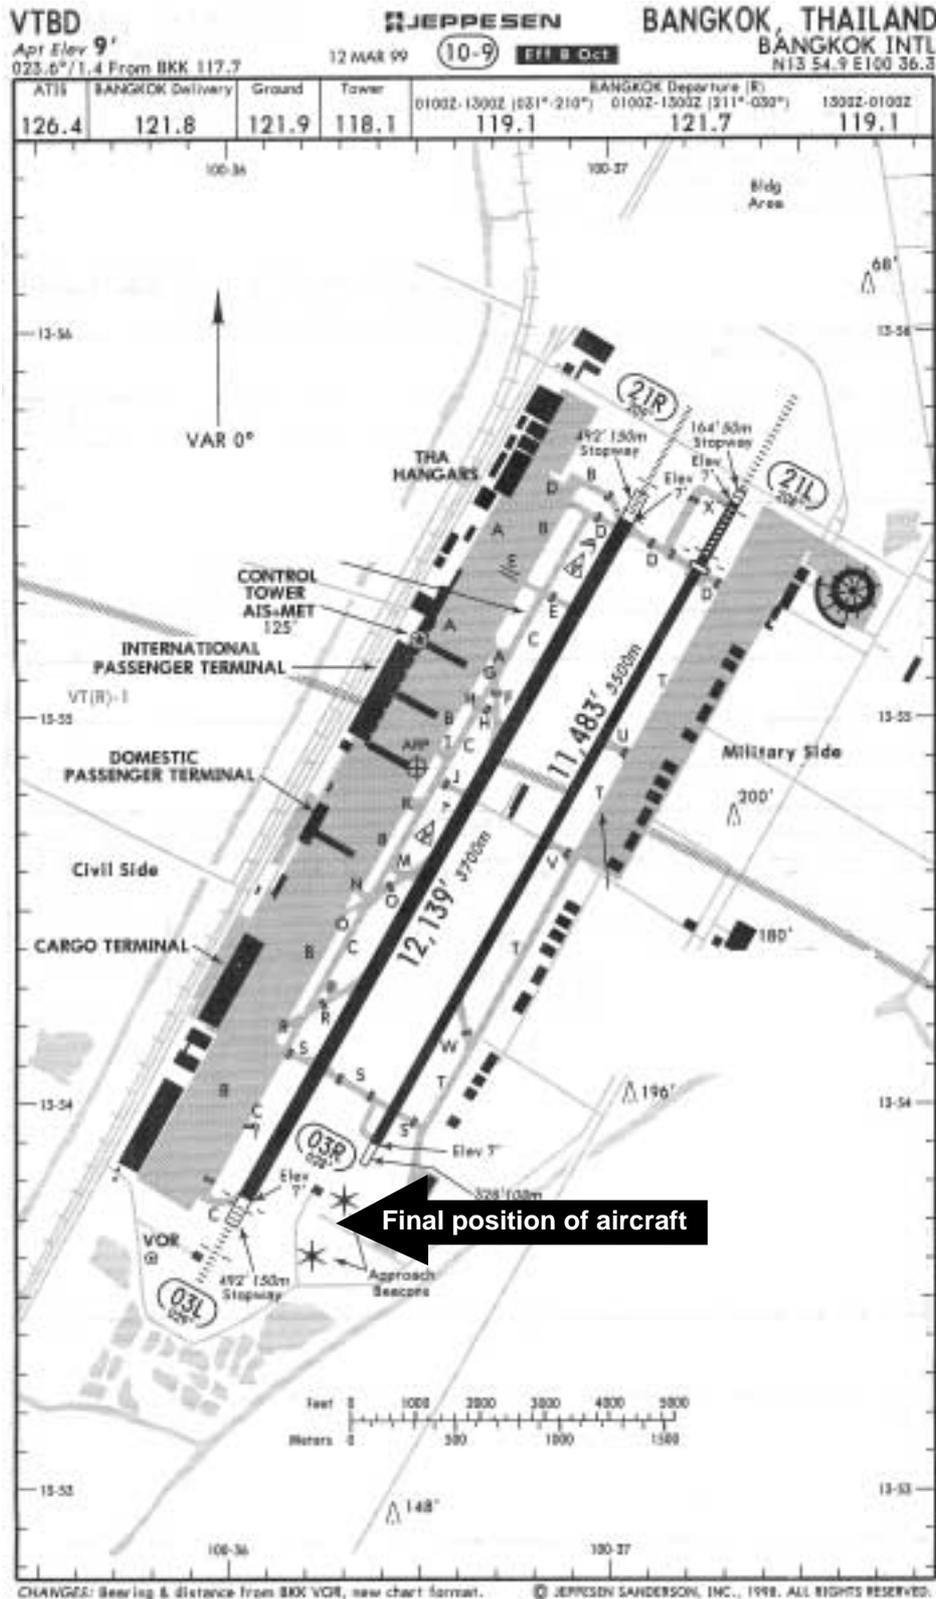
E.1 Final position of aircraft

The diagram below shows the airport chart from the Jeppesen Route Manual as used by Qantas at the time of the accident. The location of the final resting place of the aircraft is indicated by the arrow. Irrelevant text has been removed to simplify the diagram.
